NASA-TM-85853 19840003188

# **Stress-Corrosion Behavior of Aluminum-Lithium Alloys in Aqueous Salt Environments**

October 1983

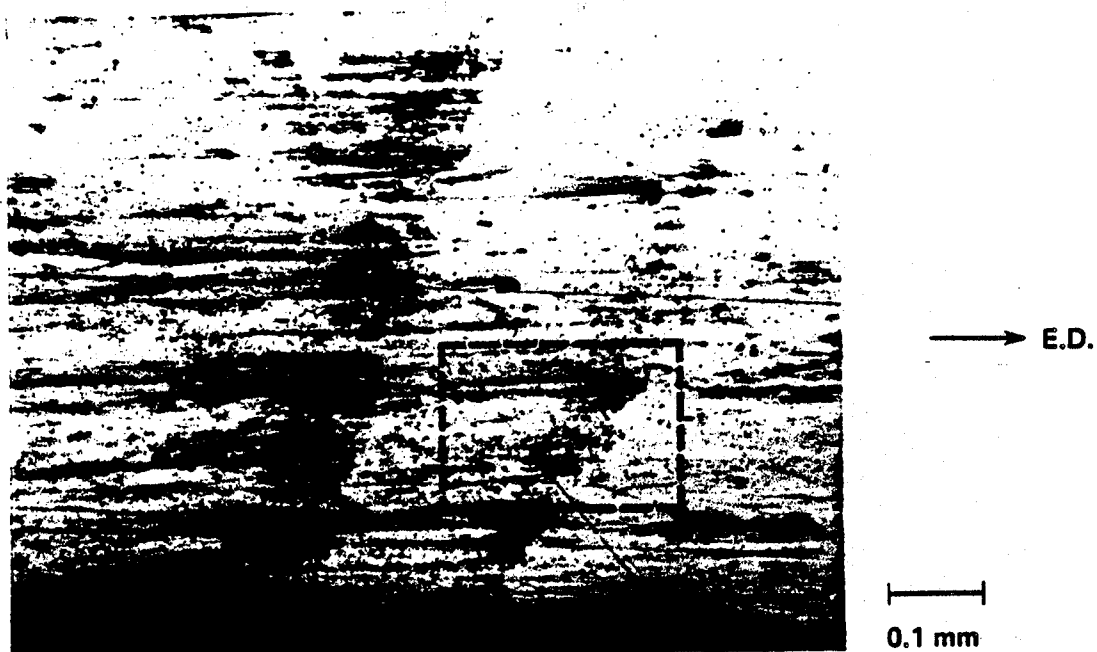
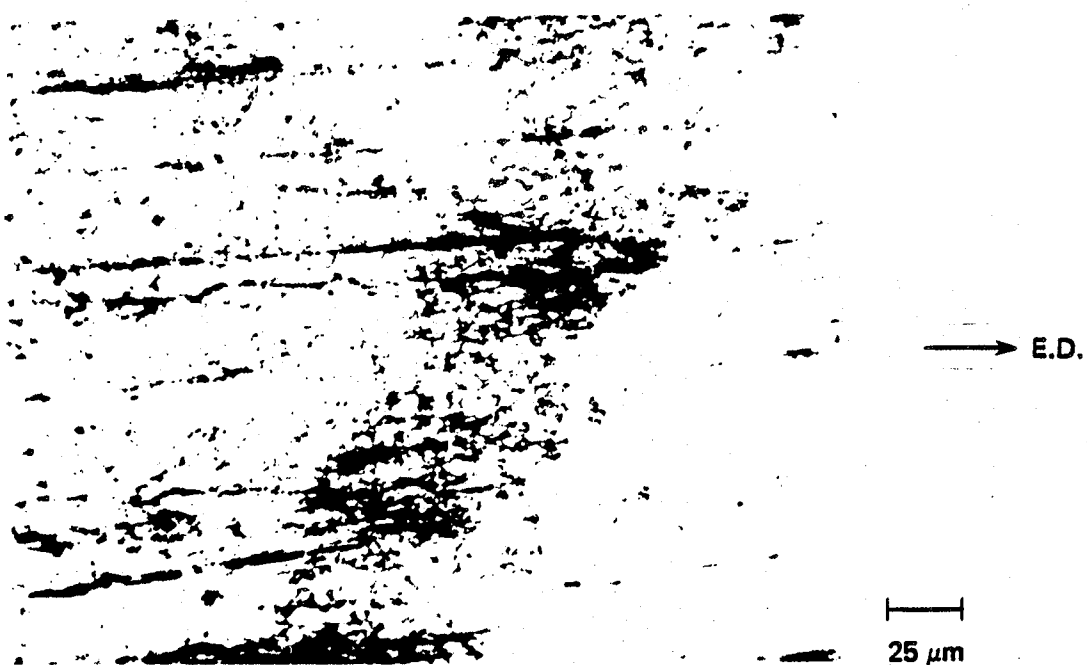
Fig. 14. Intergranular corrosion along shear-deformation bands in Al-Li-Cu base alloy DCB specimen immersed 1.4 years in 3.5% NaCl solution (as polished); (a) corroded slip deformation bands adjacent pre-crack crevice and (b) close-up of intergranular corrosion within band.

occurs at selected regions along the crack plane, as shown in Figure 17. In the P/M Al-Li-Cu alloy, intergranular corrosion is more intense in the slip deformation bands developed during fatigue precracking process, as shown in Figure 14.

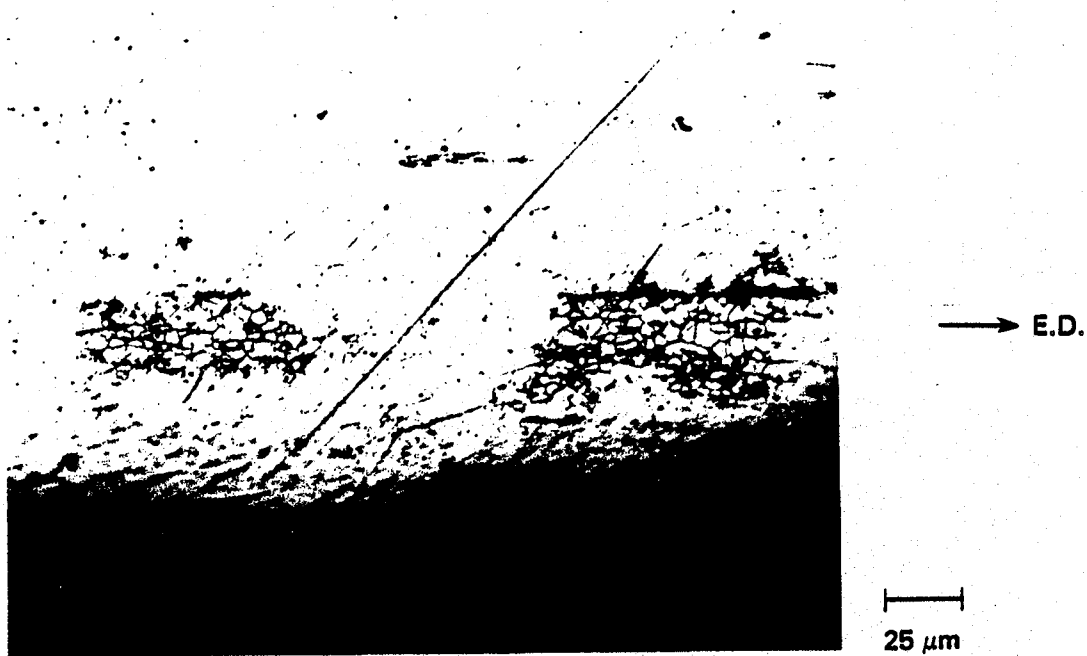
Fig. 15. Intergranular corrosion (a) adjacent machined notch and (b) at crack-tip of P/M Al-Li-Cu alloy DCB specimen (as polished).

The physical appearance of the S-L-oriented DCB specimens that underwent long-term exposure (1.4 yr) to the aqueous NaCl environment is shown in Figures 13-17. The magnesium-bearing alloy was found to be very susceptible to localized pitting, much more so than the base alloy, as shown in Figure 13. Metallographic examination of the rough-polished side-surfaces of the DCB specimens, perpendicular to the pre-crack plane, indicate extensive intergranular cracking and corrosion, both in the P/M Al-Li-Cu alloy, as shown in Figures 14 and 15, and in the magnesium-bearing alloy, as shown in Figures 16 and 17. The intergranular attack is again associated with the stringer particles aligned parallel to the extrusion direction. Intergranular attack is not localized to the region of crack growth but
